AG&G Testing and Validation Launceston General Hospital Operating Theatre 4

Test Report Number: 1962.24
AG&G testing and validation in:
287-291 CHARLES STREET
LAUNCESTON, TAS 7250
Contact: Shane Toon – 0419 146 979
Starting test date: 01/11/2024

Document type	Validation protocol		Date	01/11/2024	Page	2/28
Document title	OT4 Annual AG&G testing and validating		Report No.	1962.24	Rev.	0
					Class	ISO 7

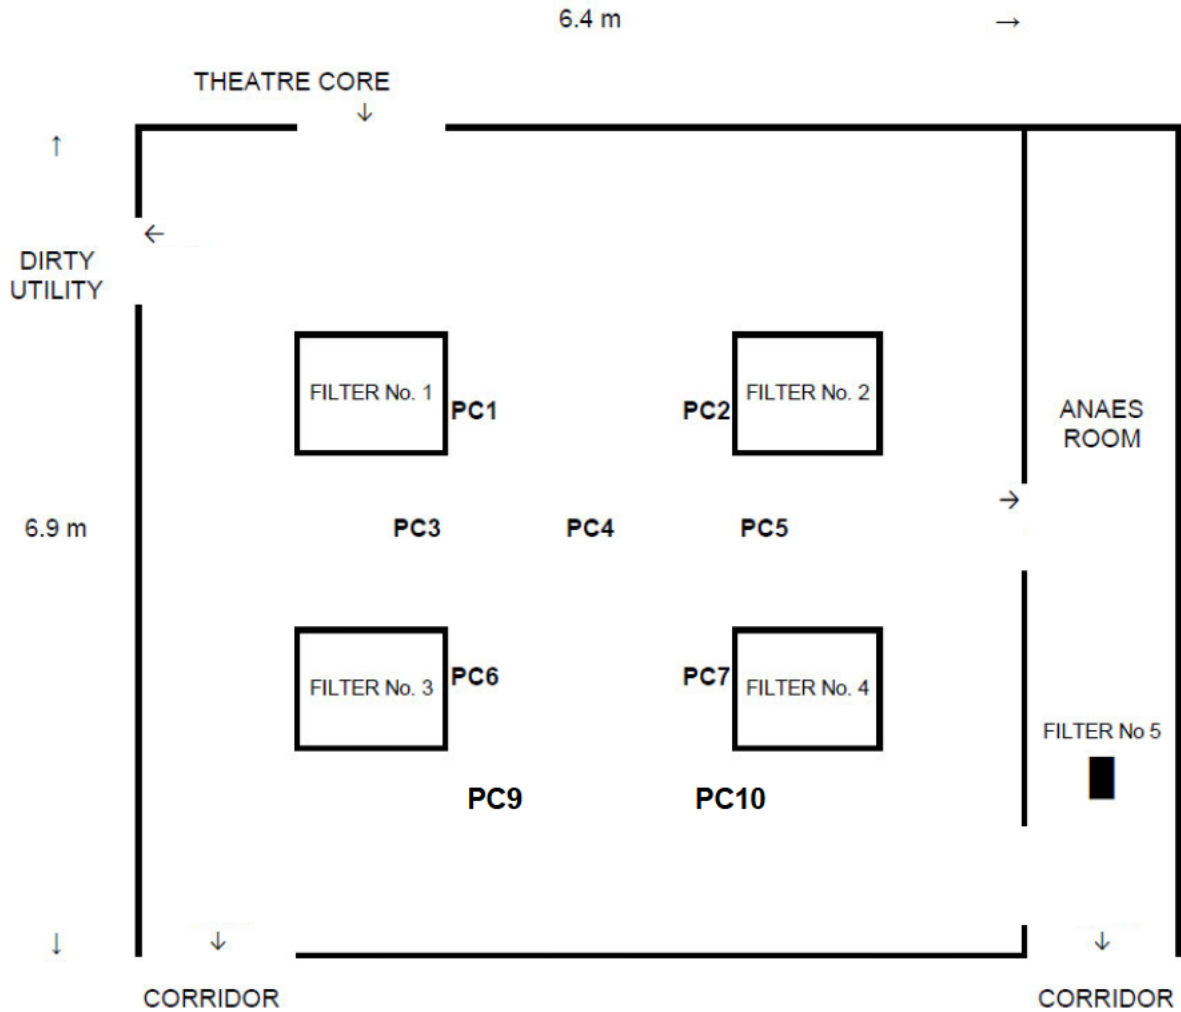
Below map showing particle count sampling locations:

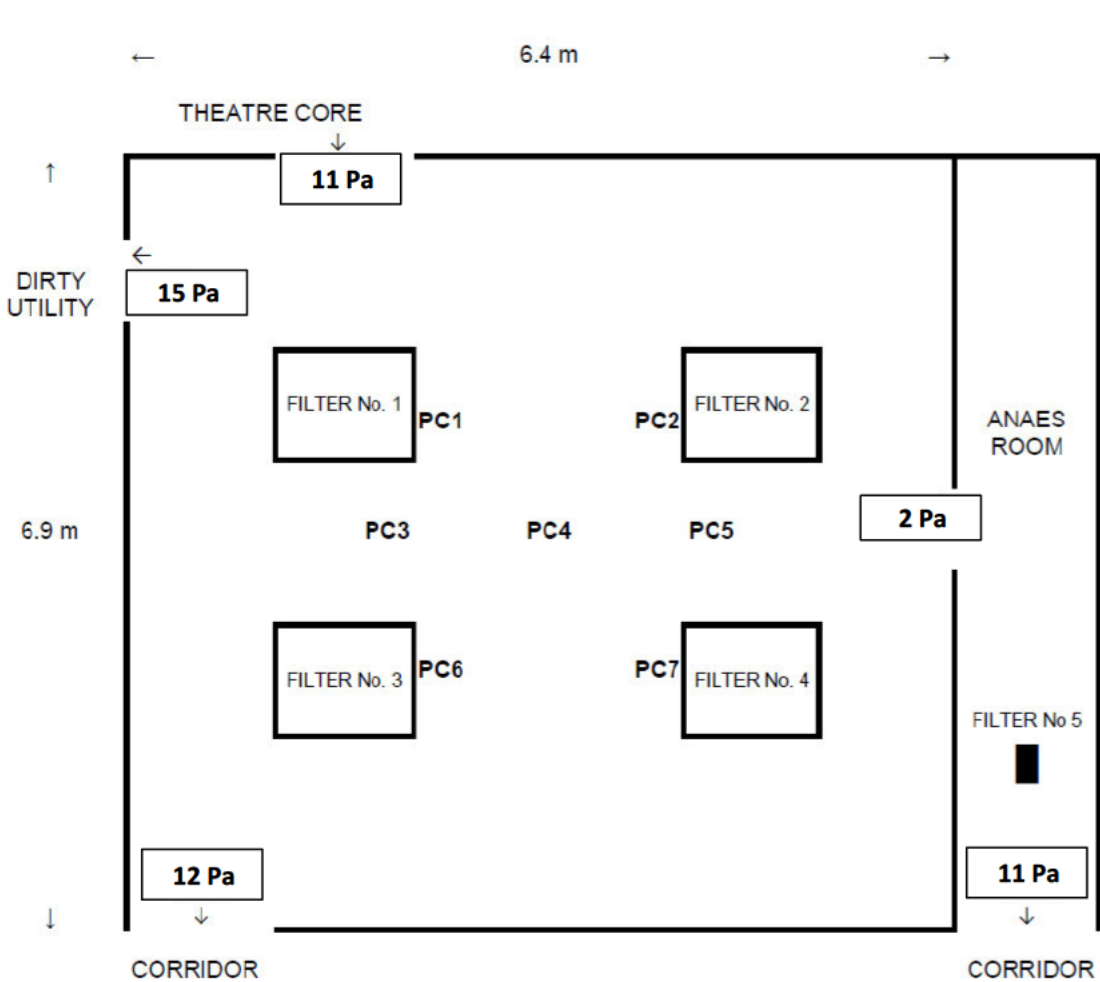
8.5. Data recorded

Below layout with data recorded accordingly to procedure above:
